## **FAILZERO Dry Lubricant Treatment Testing and Evaluation Report**

# **DoE/Unwin Sand Test**

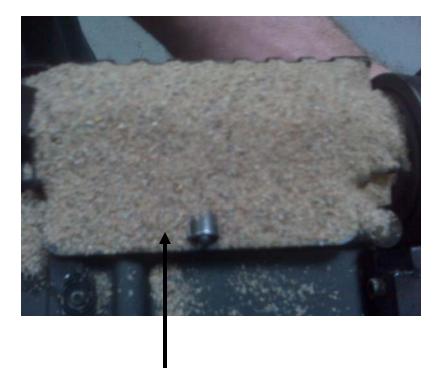
Ejection port door open

- Picture of open ejection port door that has been filled with sand
- Re-sanded every magazine
- Weapon shook before attempting to fire

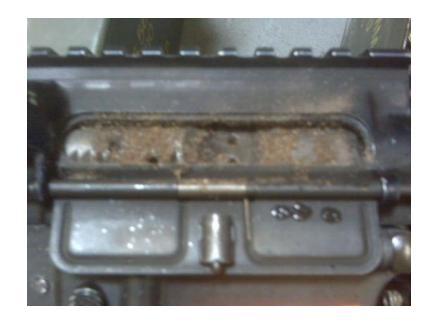
# Overlubed M4

- Picture of open ejection port door after shaking sand off
- Note the clumps of sand
- Weapon fired 63 rounds prior to failure

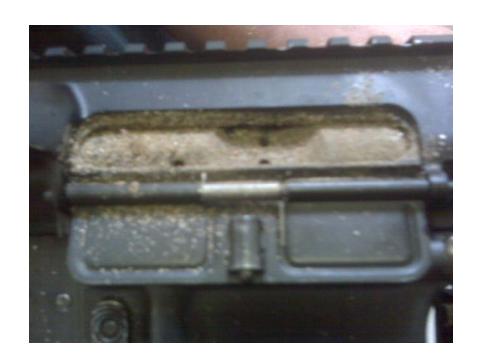
# Properly Lubed M4

- Picture of open ejection port door after sand has been shaken from the weapons
- Note the even film of sand on the carrier
- Weapon fired 52 rounds prior to failure

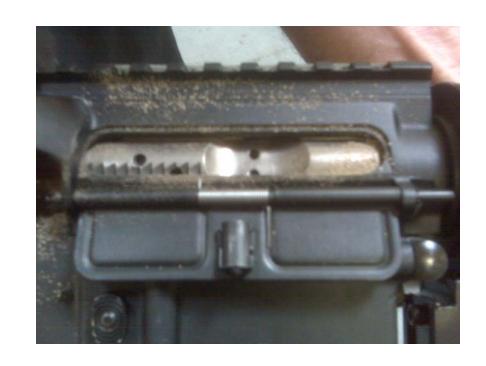
# FailZero BCG (no lube)

\* Because the test rifle performed so well during the dust/sand test, we attempted to fire an additional 100 rounds, following the above guideline. At 154 rounds the test rifle did malfunction due to a failure to extract. This was primarily due to sand getting into the chamber and acting like sandpaper between the cartridge and chamber preventing extraction though the normal cycle of operation. The test was concluded at this point.

- Picture of open ejection port door after sand has been shaken off of the weapon
- Note the limited amount of sand that adhered/remains on the carrier
- Weapon fired 154 rounds prior to failure
